Second Five-Year Review Report

Mystery Bridge Road at Highway 20

**Natrona County
Casper, Wyoming**

September, 2004

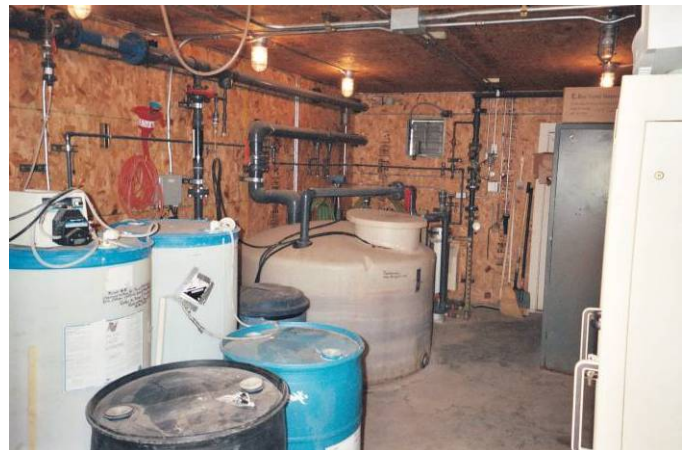
DOW/DOWELL Facility - Groundwater treatment equipment building

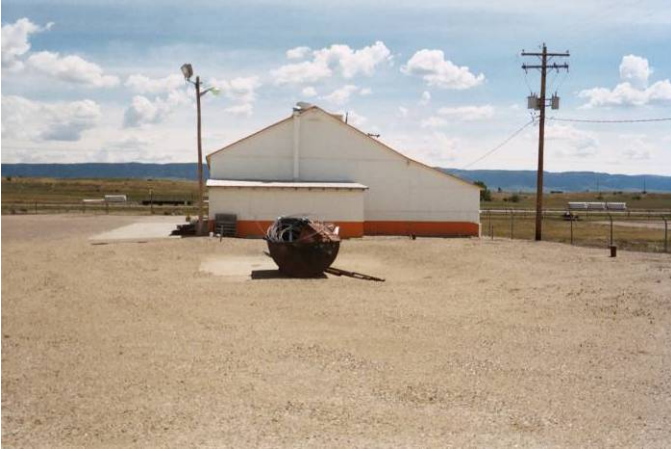
DOW/DOWELL Facility - Vehicle service building and former infiltration gallery - view to south

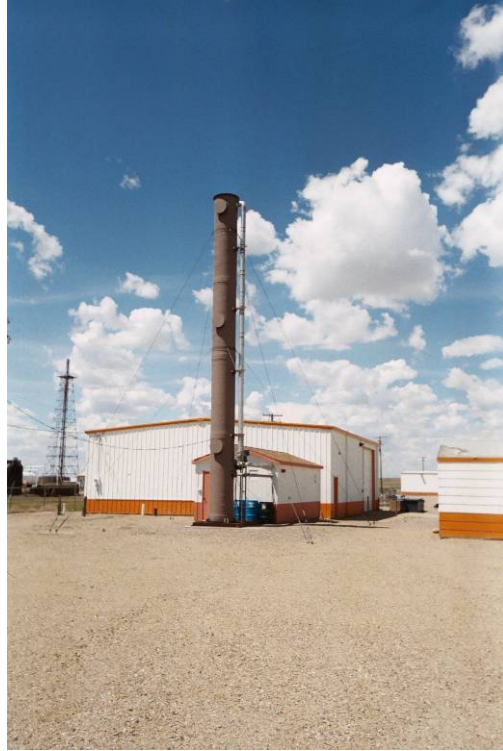
DOW/DOWELL Facility - Air stripping tower - view to north
